44.1

Engine temperature too high

All variants of the following models:

L1700 L2000 L2400

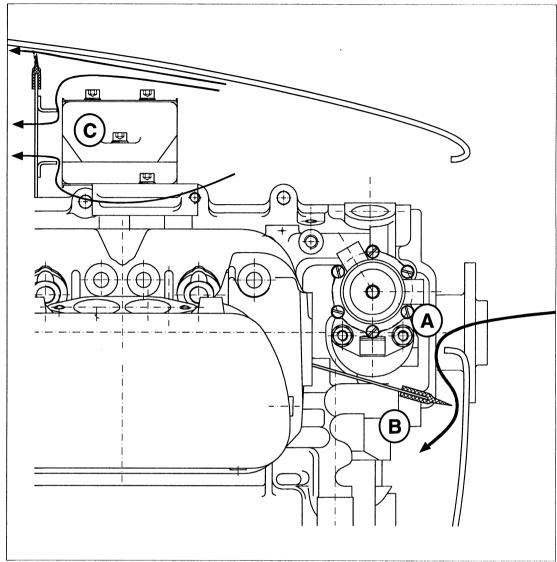
Fig. 1 Possible sealing problem zones

Improvement of the airflow through the oil cooler.
There is often leakage from points in the cooling
system around the oil cooler. The sealing on the
top of the oil cooler is often mechanically instable, so that the sealing strip does not fit, or is
a bad fit on the cover. The resulting gap offers
the air a small flow resistance. Sometimes the
contact pressure of the sealing strip is too low to
resist the ram pressure (refer also to Fig. 1 and
Fig. 3).

- 1. Check the temperature indication for correctness.
- 2. Retrofit an indicator for the cylinder-head temperature.
- 3. Carry out an inspection of the engine. Check the ignition timing and the carburetter setting. Check the induction system for leakage.
- 4. Inspect the condition of the cooling baffles. Repair cooling baffles which leak or are damaged.
- 5. Inspect the sealing between the engine cowling and the cooling baffles, repair if necessary. Check the effect of the sealing strip. When the cowling is installed, the edges of the seal must be curved towards the direction of flight. Replace any rubber parts which have become hard¹.

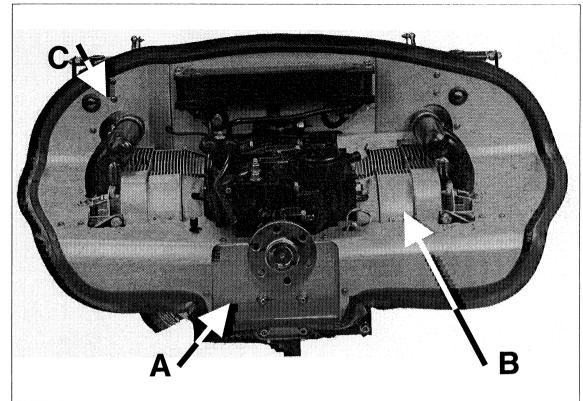
Fig. 20 Example of a good design for the casing

A good design for sealing is shown in Fig. 20. The edges are provided with a sealing strip which provides a seal with the engine cowling. The perfect seal under the propeller boss (A) can be seen and the attachment of the shell type baffles. The casing is divided on both sides of the intake pipes (C) to make the installation easier and also, because of the design, to minimize the gap around the intake pipes and at the oil cooler.
